# NATIONAL BUREAU OF STANDARDS REPORT

QUARTERLY REPORT FOR THE PERIOD ENDING JUNE 30, 1967 ON

INVESTIGATION OF THE DIRECTIONAL EFFECTS  
IN THE STRESS CORROSION OF ALUMINUM ALLOYS

National Aeronautics and Space Administration  
George C. Marshall Space Flight Center  
Huntsville, Alabama

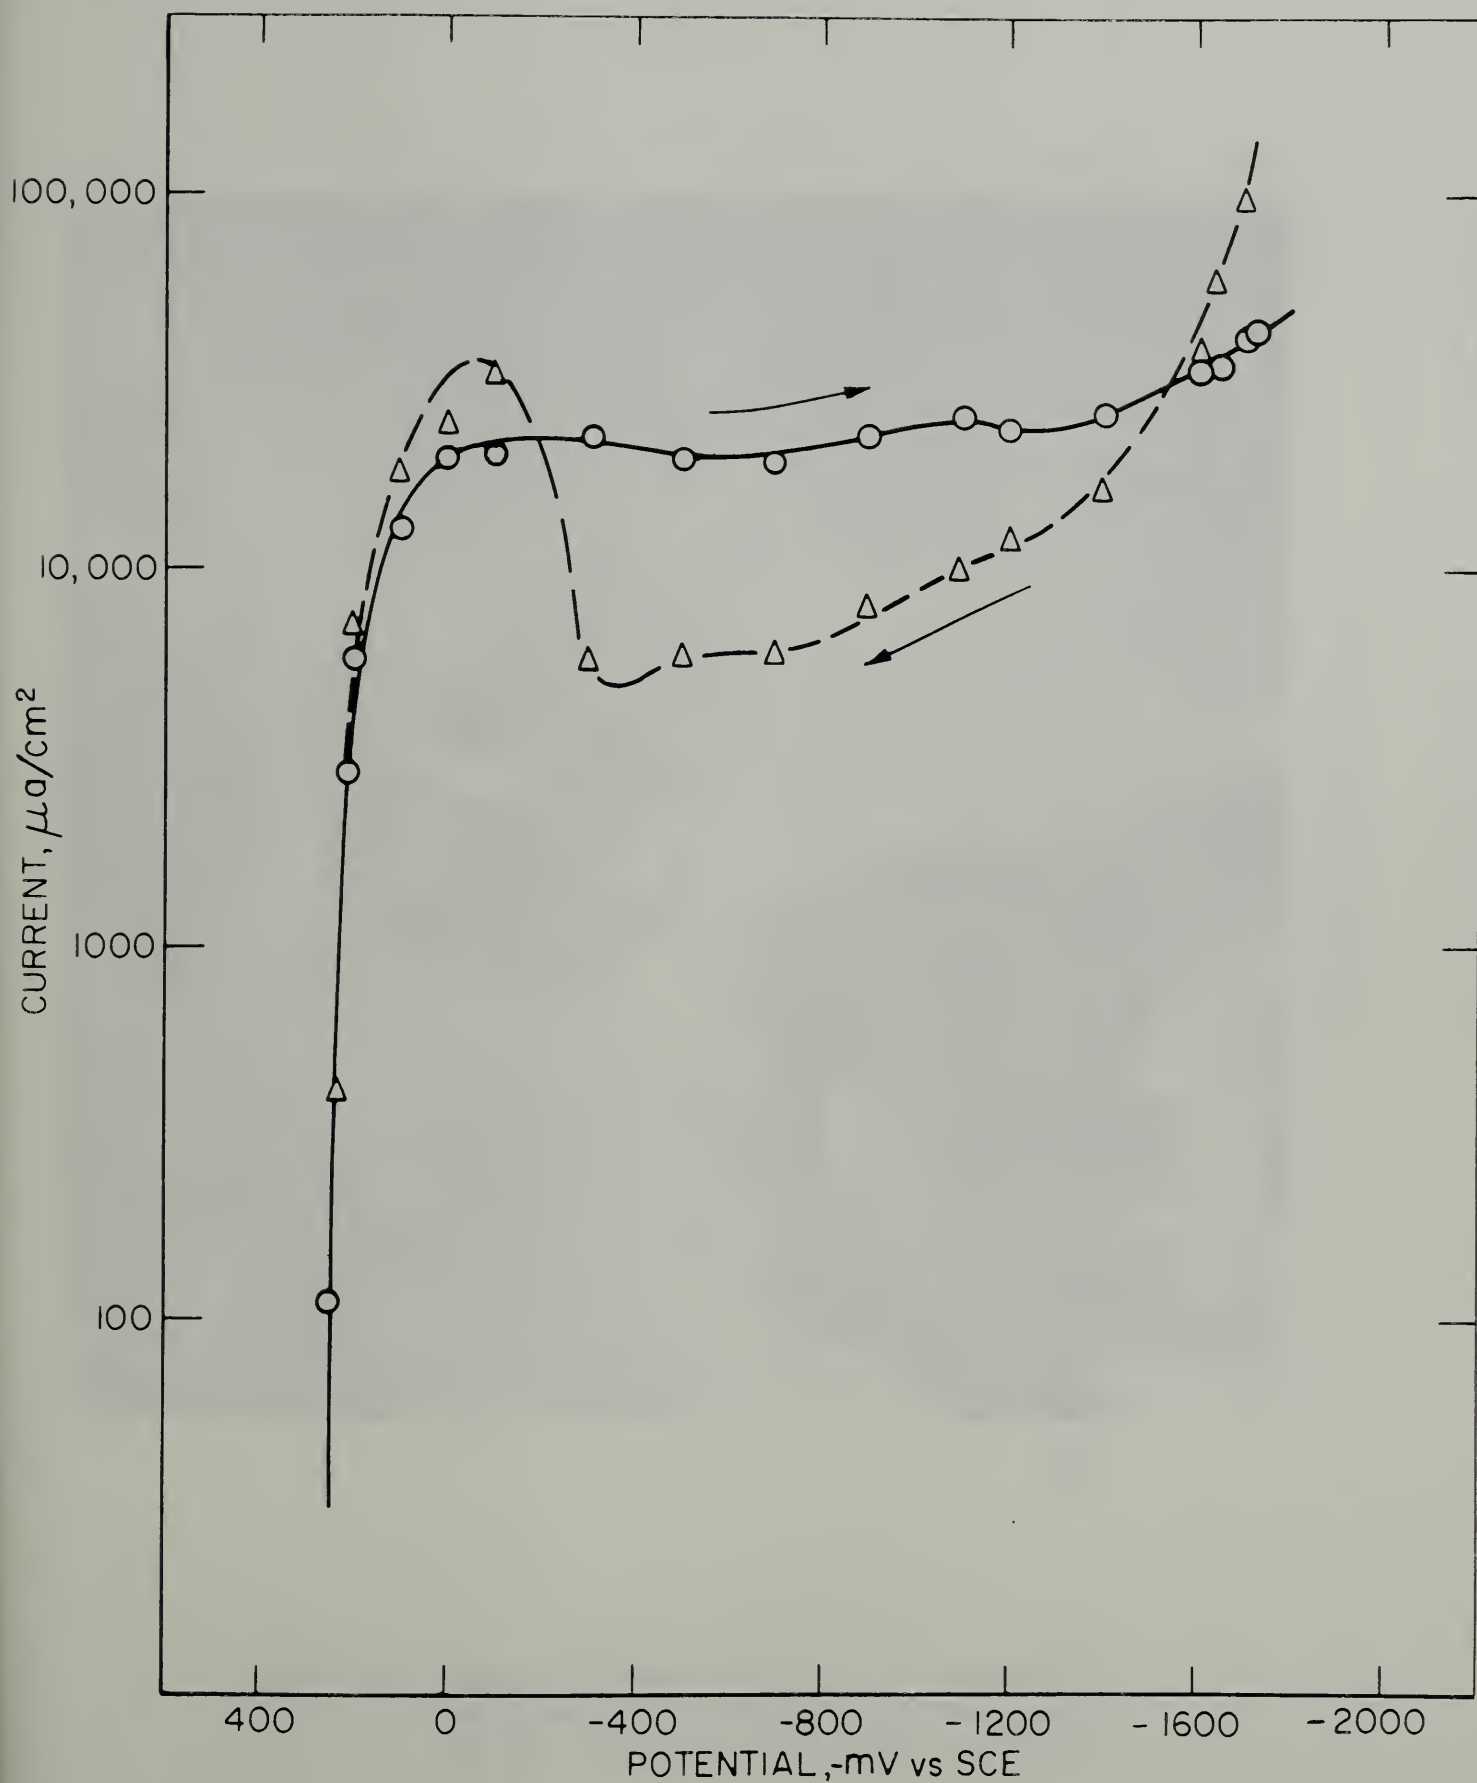
FIGURE 11. ANODIC POLARIZATION CURVE FOR 7075-T651 IN 1.0N  $\text{NaNO}_3$  (pH = 0.9 WITH  $\text{HNO}_3$ ).

Polarization curves were constructed for the 7075-T651 alloy in each of the environments previously described. The potential was varied in both an anodic as well as a cathodic direction, and current readings were made only after a steady state value was reached. At least three sets of data were obtained in each environment. The curves obtained are shown in Figures 6 through 11.

Figures 6 through 11 are the polarization curves for the 7075-T651 alloy in chromate environment, 3.5% sodium chloride, and the 1.0N sodium nitrate solutions. The obtaining of these curves is the first step in our electrochemical studies of the role of directionality on mechanism of cracking. The open circuit potentials are labeled on these curves for the chromate and for the chloride solutions and cracking does occur at these potentials.

The anodic nitrate curve shows a definite break, and this can be interpreted as being related to the formation of a passive film. This break occurs at approximately +400 mV vs SCE and, as this curve shows, is a more well-behaved system. Efforts will be concentrated on looking at the role of film breakdown and directionality for this system where chloride ions can be added in small increments. This way, the onset of breakdown can then be related to cracking.

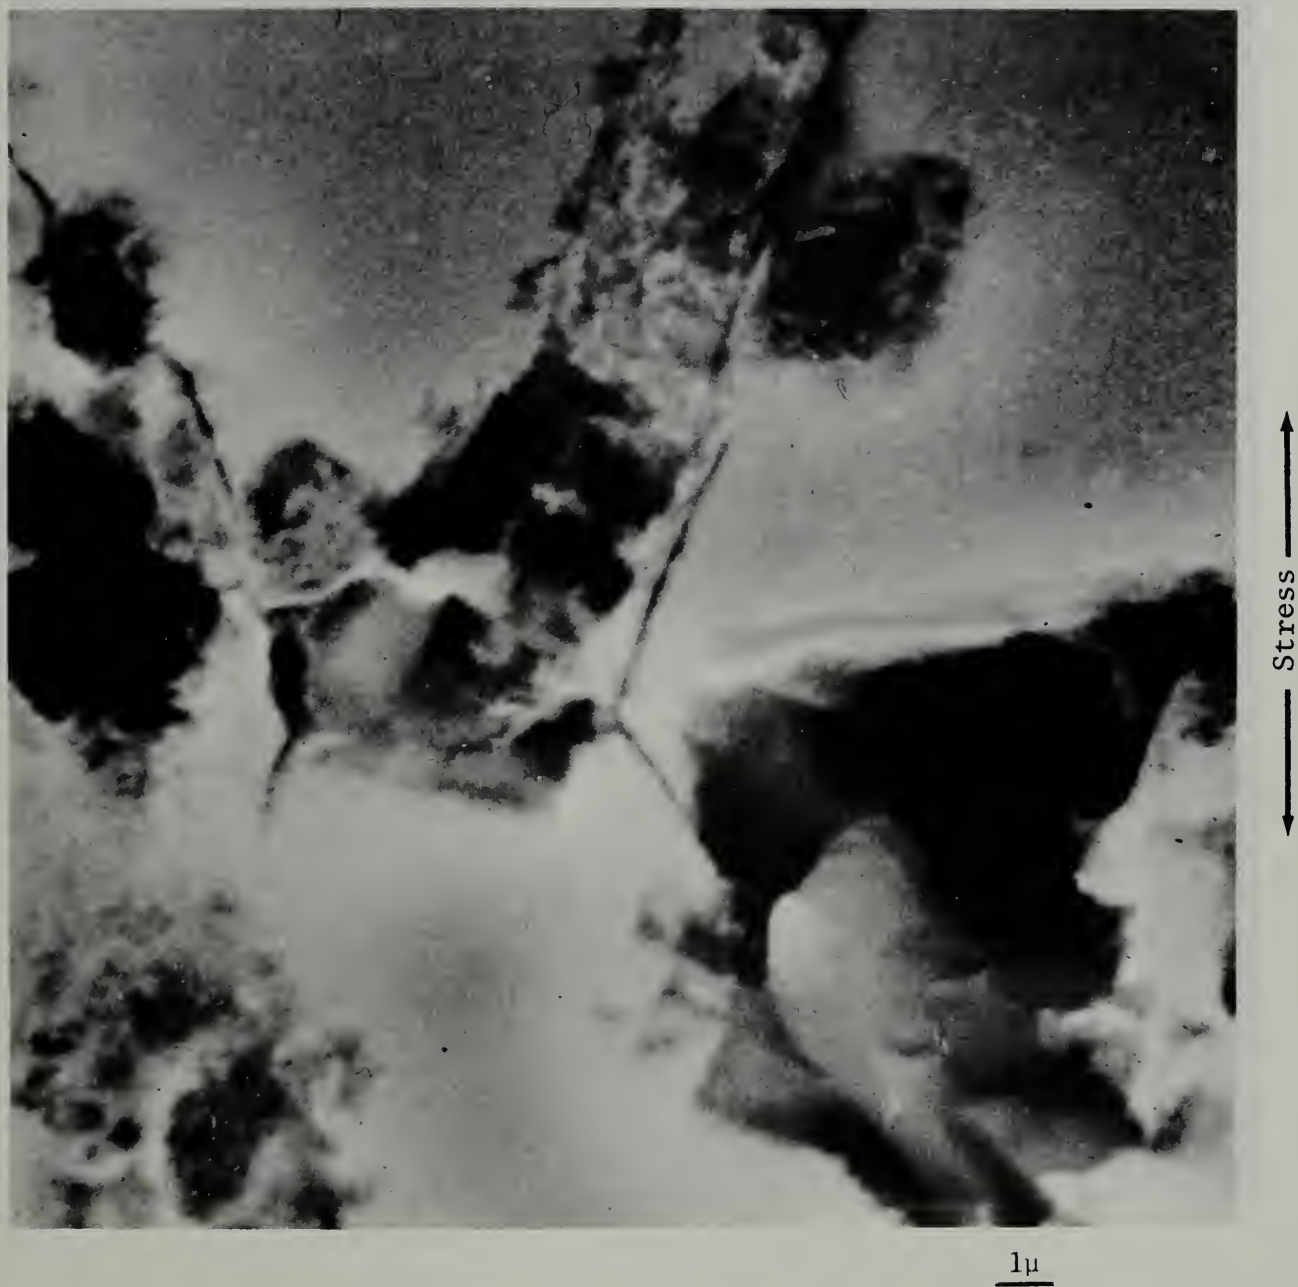
Figure 12. SEM micrograph showing S.C. cracks in longitudinally stressed specimens after 30 sec. exposure in chromate solution. X7,500

Observation of the surface condition of stress corroded specimens utilizing the scanning electron microscope enabled study of the crack initiation process in the 7075-T651 alloy. Cracks were seen to initiate in as short a time as 30 seconds in the longitudinally stressed specimens (Figure 12). Successively longer exposure times produced cracking as shown in Figures 13 through 18. Cracking was found to occur primarily at the ends of the elongated grain boundaries, normal to the applied stress, as shown in Figure 14. This figure also points out the difficulty in studying crack initiation by low magnifications. The same crack can

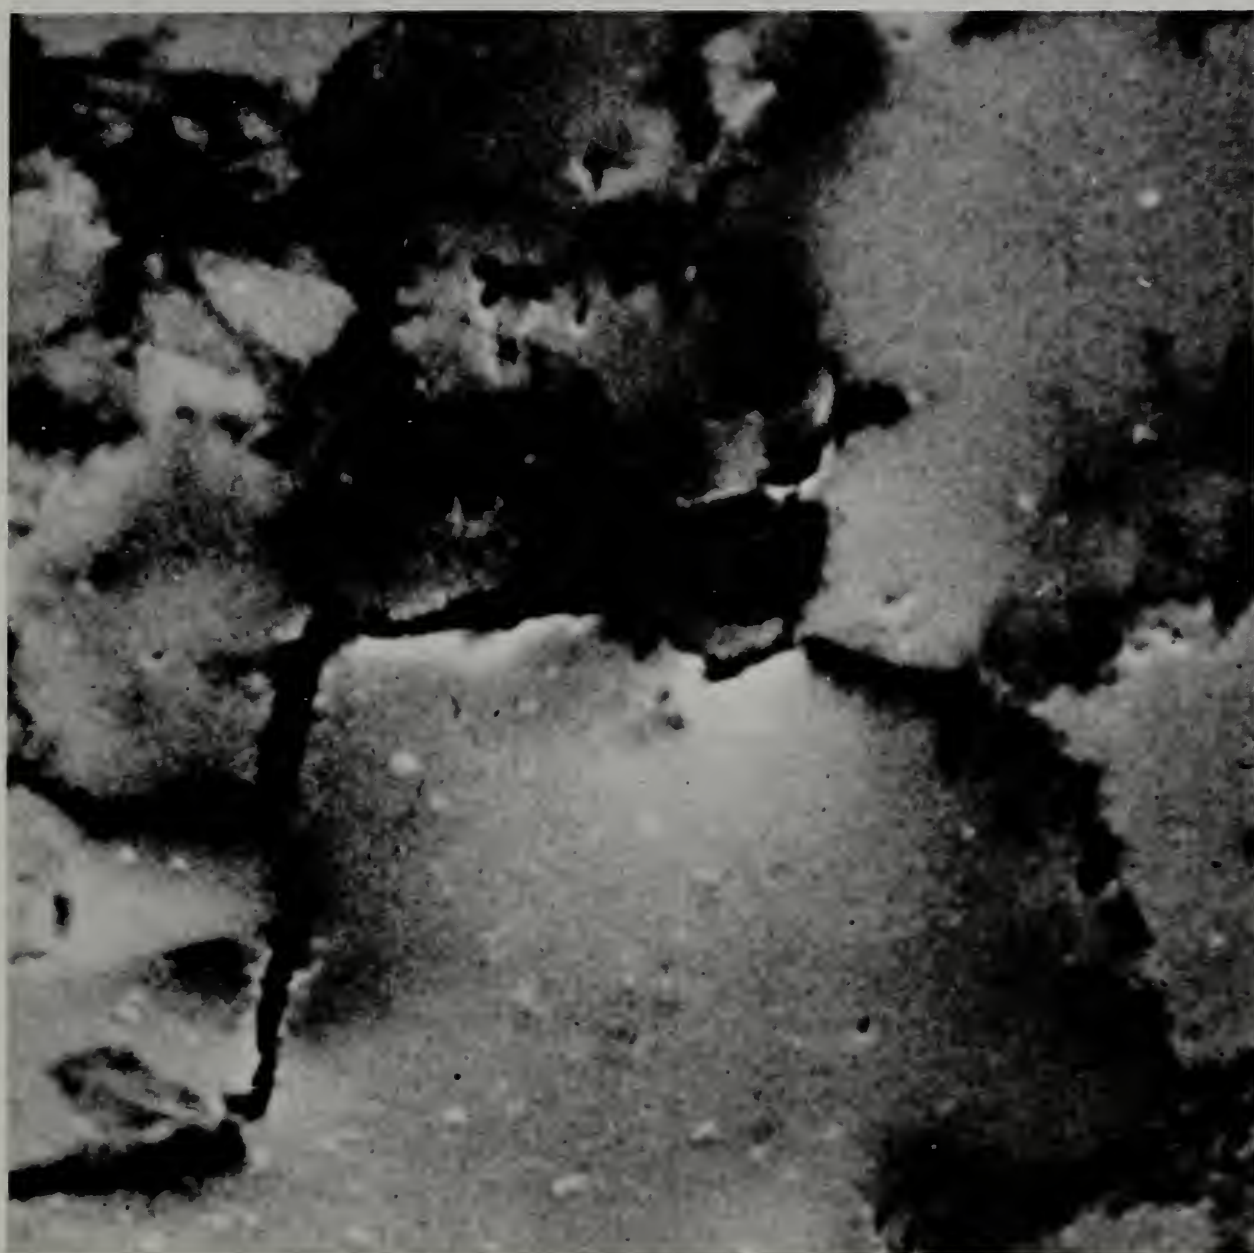
Figure 13. SEM micrograph showing S.C. cracks in longitudinally stressed specimen after 2 min. exposure in chromate solution. X15,000

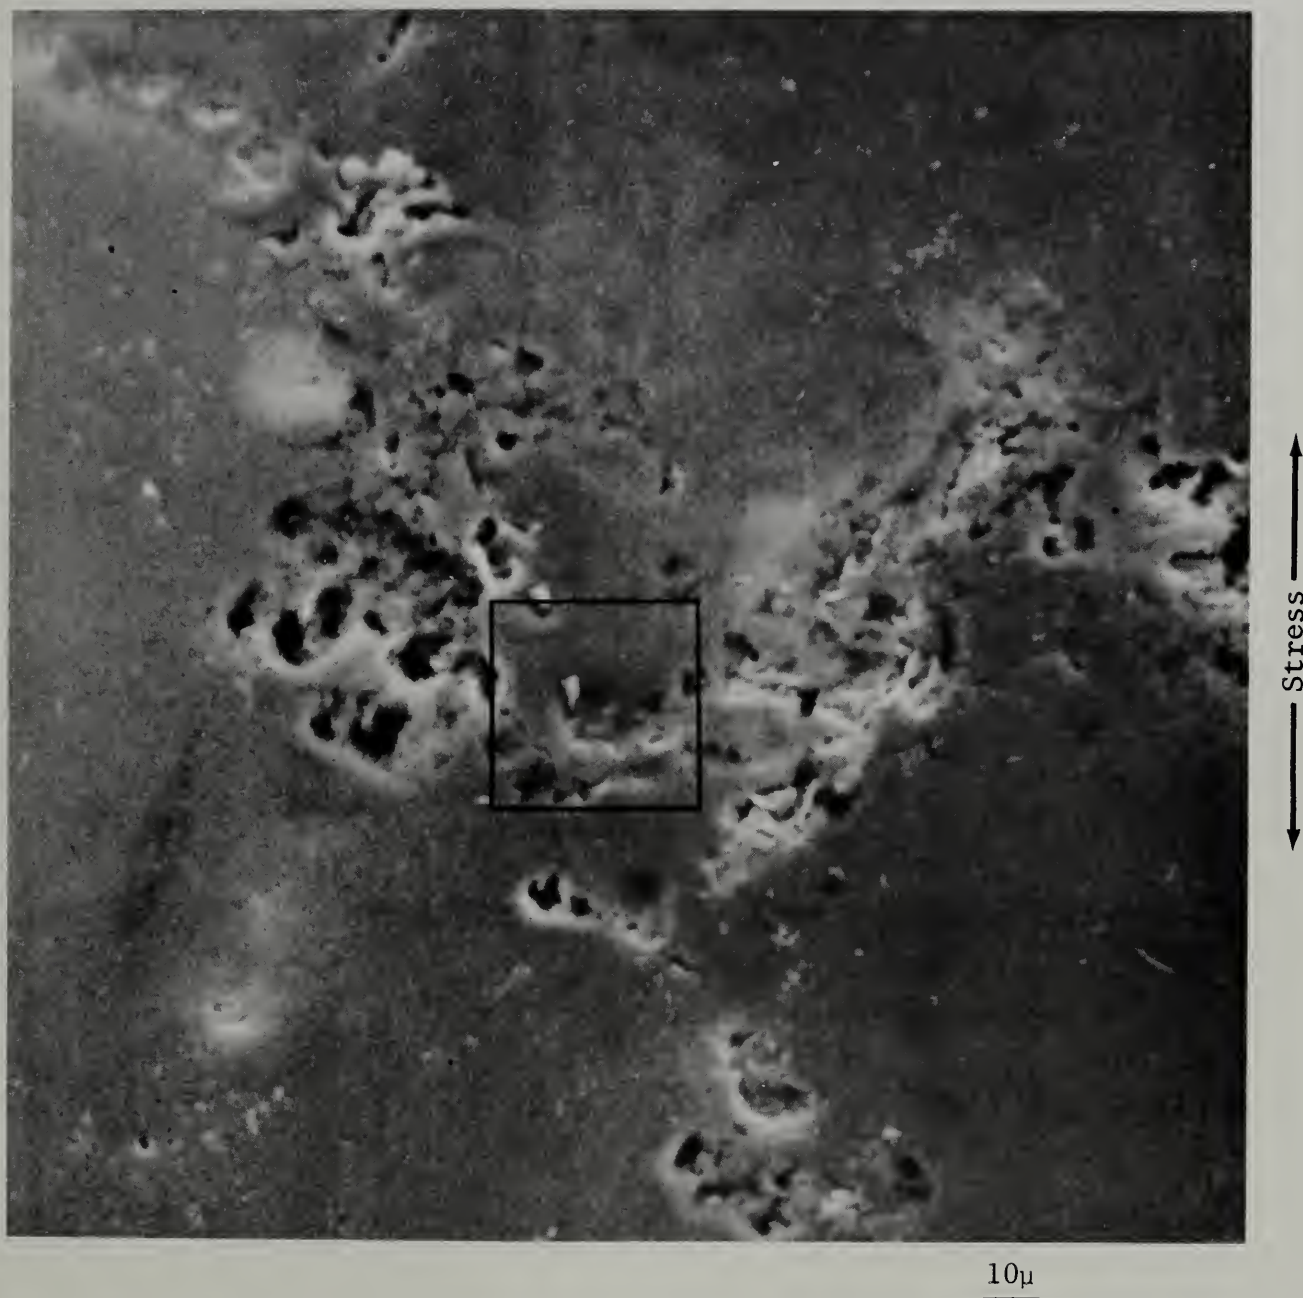
Figure 14. SEM micrograph showing difficulty of locating S.C. cracks at lower magnifications on longitudinally stressed specimen after 5 min. exposure. Note cracking at the end of the elongated grain where the boundary is normal to the applied stress. X750

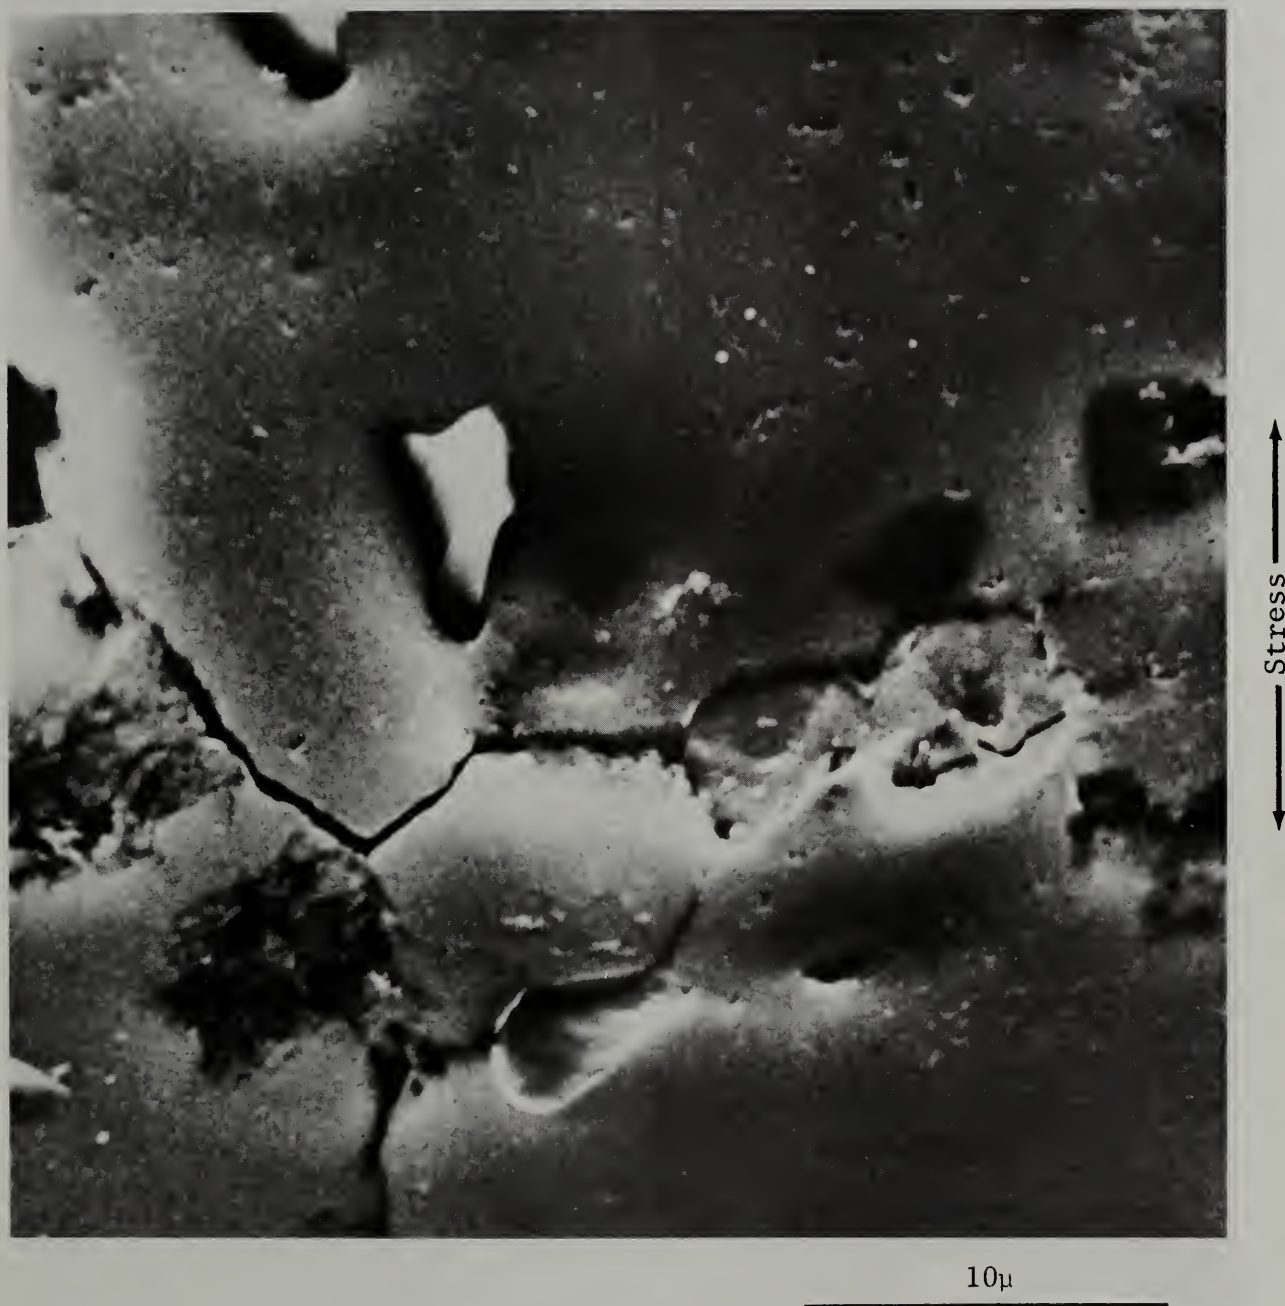
Figure 15. SEM micrograph of area marked in Figure 14. Note cracking at the end of the elongated grain where the boundary is normal to the applied stress. X4,500

clearly be seen in Figure 15 at the higher magnification easily obtainable in the scanning electron microscope. Cracking after 7 minutes exposure (Figure 16a and 17a) was confirmed by releasing the stress on the specimens and observing closure of the crack (Figure 16b and 17b). Stress corrosion cracks on the surfaces of specimens exposed for 5 to 7 minutes were seen to have propagated to approximately the same extent as cracks on a specimen exposed for 16 hours (Figure 18).

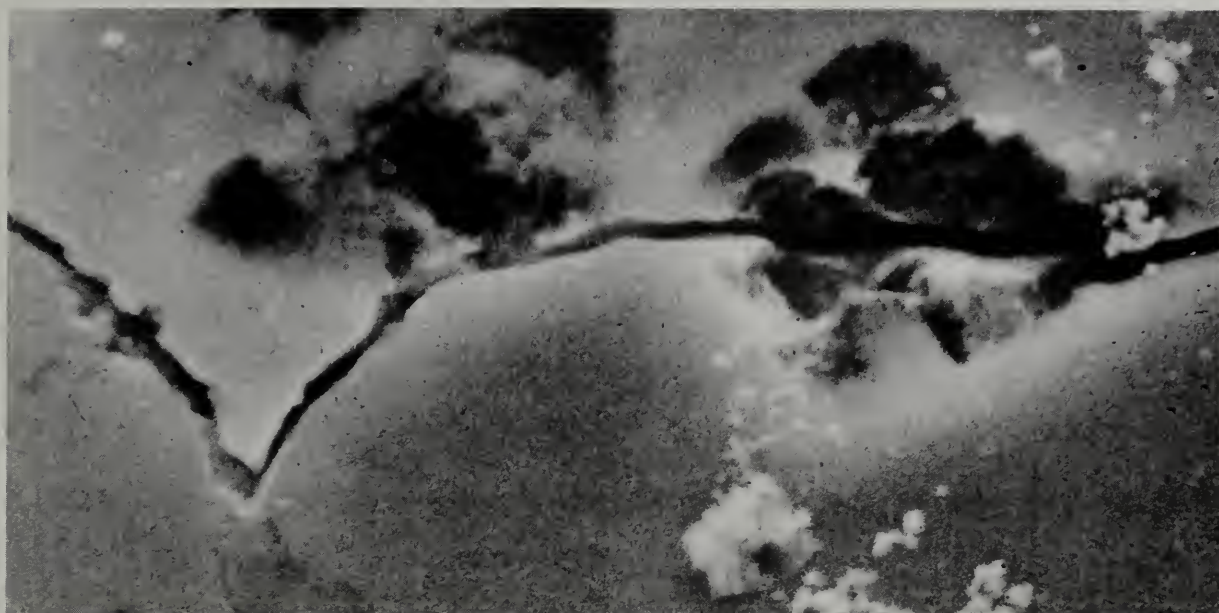
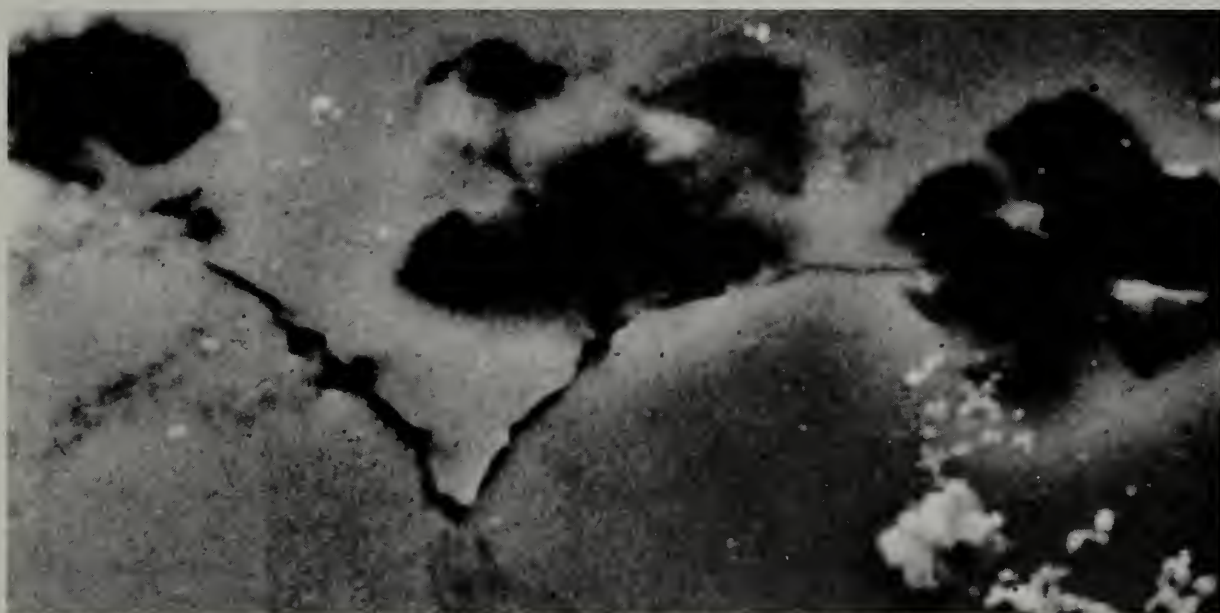
Figure 16. (a) SEM micrograph of a longitudinally stressed specimen after 7 min. exposure in chromate solution. X4,500  
 (b) Micrograph of same area after releasing the stress on the specimen. Note closure of the crack. X4,500

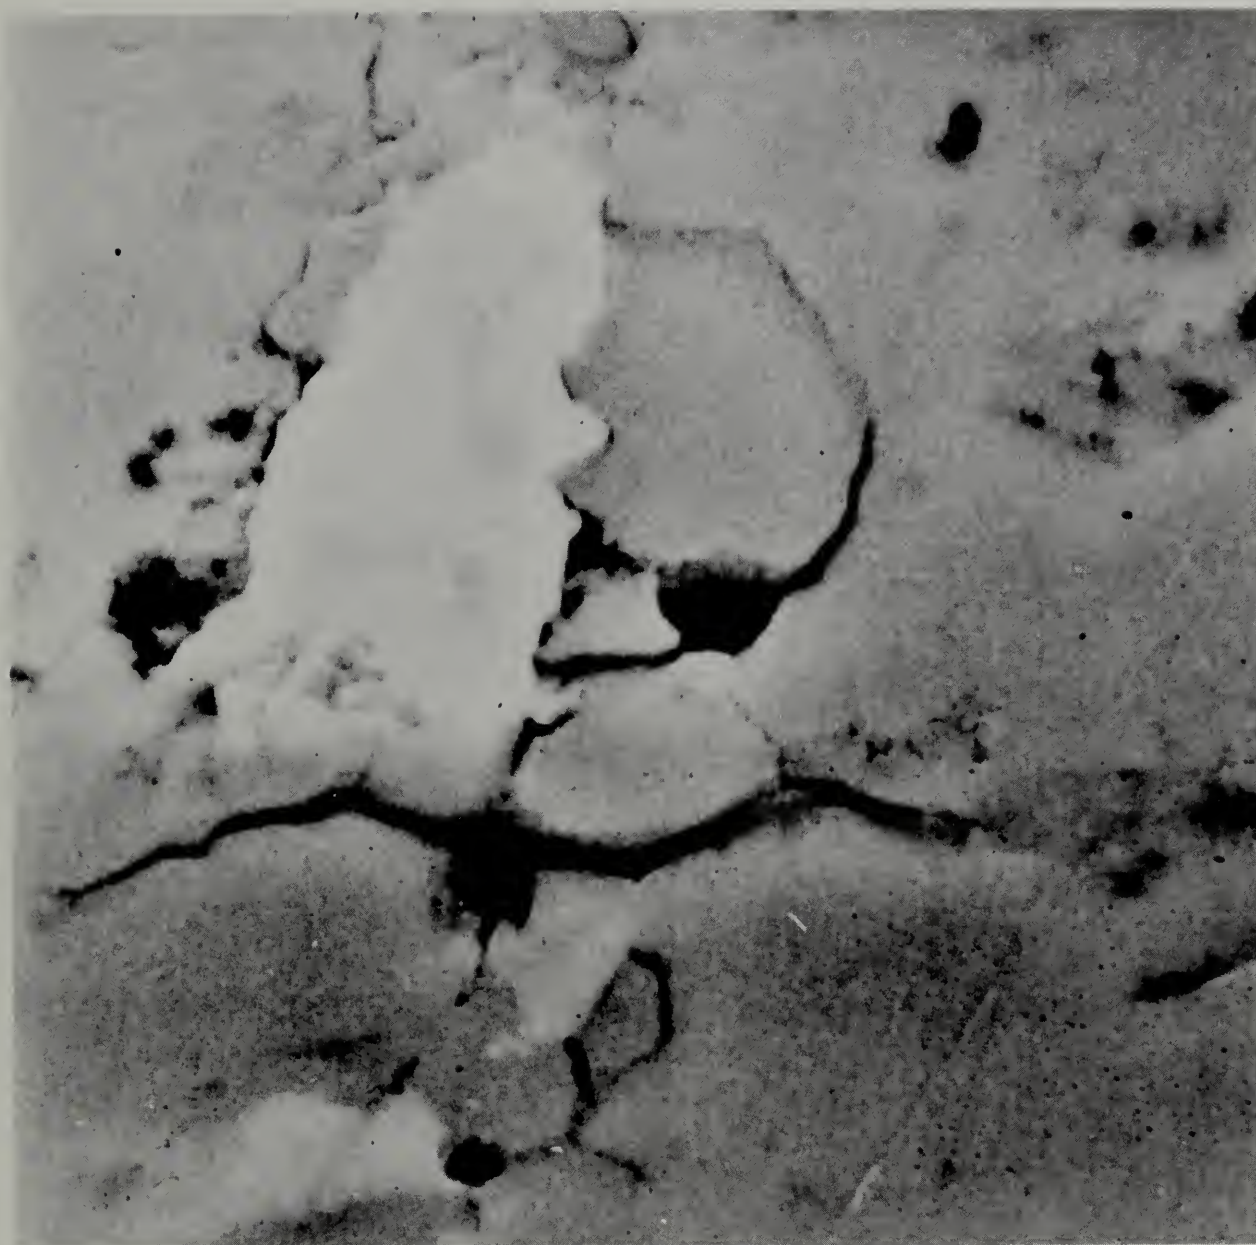
Figure 18. SEM micrograph of longitudinally stressed specimen after 16 hours exposure to chromate solution. The general condition of the specimen was similar to that of a specimen after 7 min. exposure with little additional crack propagation. X4,500

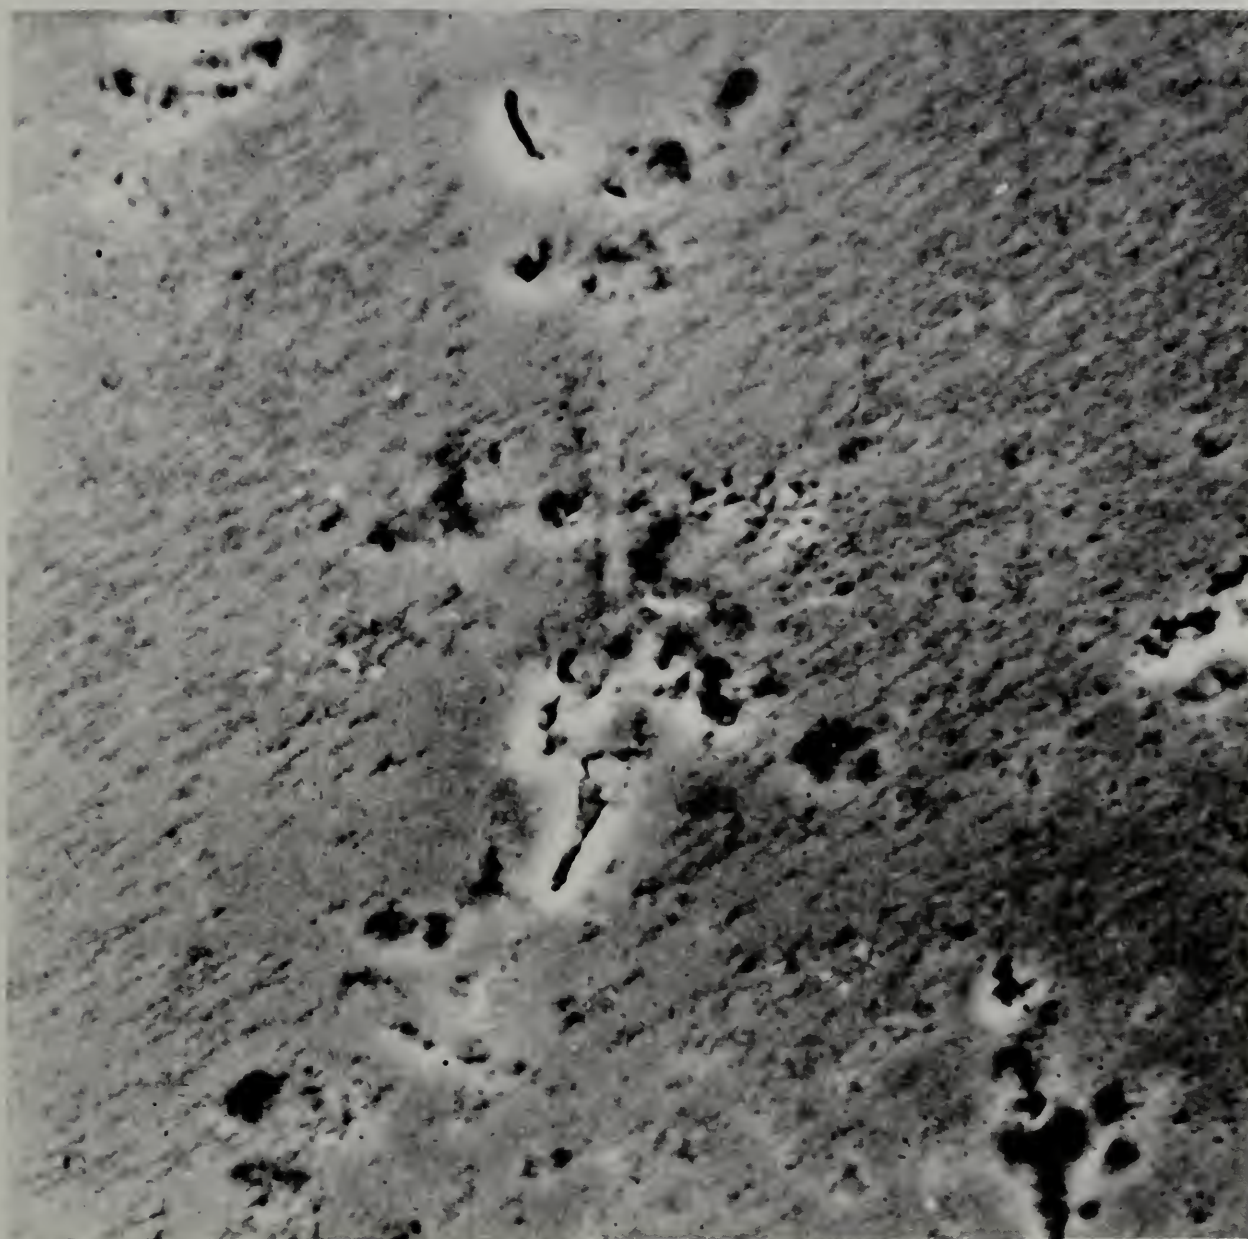
Figure 19. SEM micrograph of surface of unstressed specimen exposed to chromate solution for 10 seconds. Note a large amount of general pitting as compared to specimens corroded under stress. X1,500

Figures 19 through 21 show surfaces of unstressed specimens exposed for 10 seconds and 5 minutes, respectively. General pitting has occurred to a much greater extent on the unstressed specimens than on the stressed specimens seen earlier (Figures 12 through 18). The stifling of general pitting on specimens undergoing stress corrosion cracking may be due to the stressed boundary areas suitably oriented for cracking to occur becoming considerably more anodic than those anodic areas normally susceptible to pitting attack. The net effect would be inhibition of general corrosion by an internal cathodic protection mechanism.

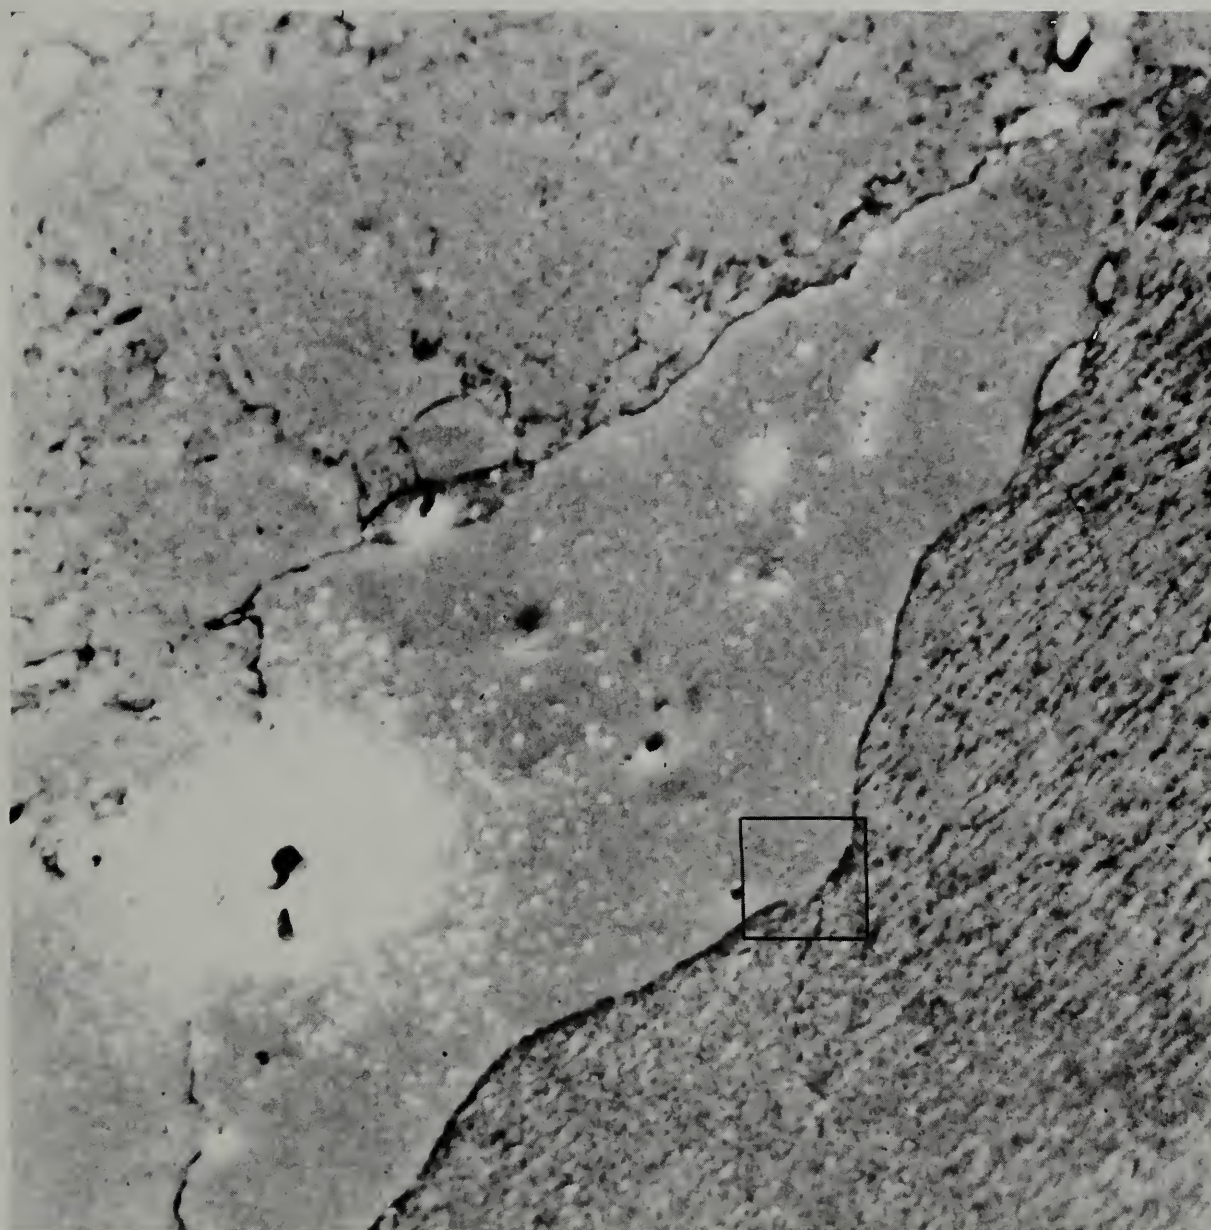
Figure 20. SEM micrograph of surface of unstressed specimen exposed to chromate solution for 5 min. Note what appears to be cracks at the grain boundaries at this magnification. See Figure 21 for greater detail along boundaries. X1,500

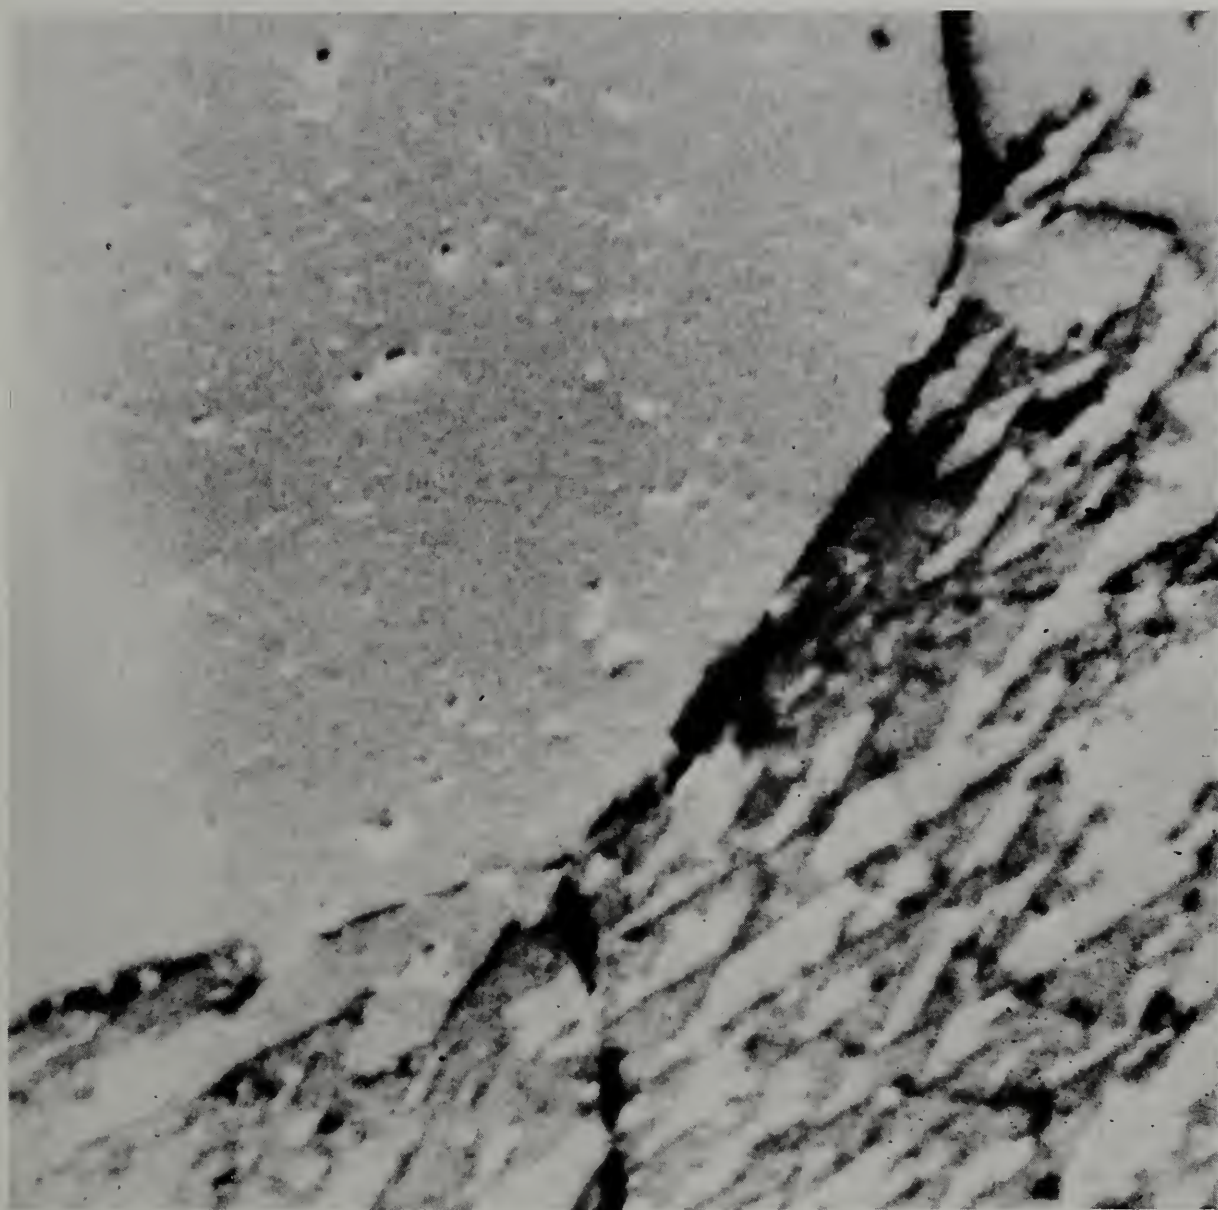
Figure 21. SEM micrograph of area marked in Figure 20 after 5 min. exposure to chromate solution shows general grain boundary etching rather than cracking.  
X15,000
